Maryland Historical Trust
State Historic Sites Inventory Form

Survey No. CARR-1231

historic Patterson House

2. Location Springfield Hospital Center

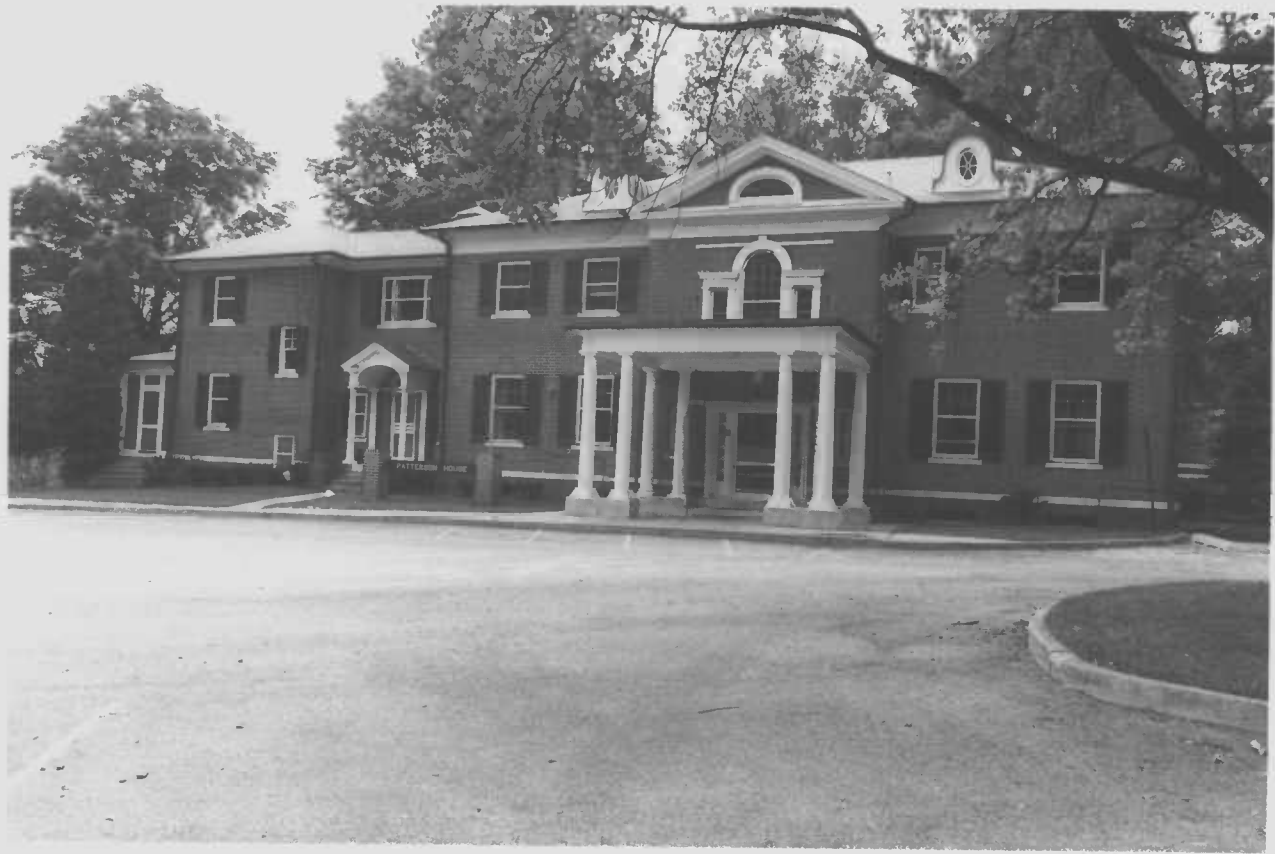
North

The pedimented gable occupies the central bay of the five bay facade. The pediment forms a pavilion for the central bay which is flanked by two bays on each side. A Diocletian window is located in the center of the gable. Two rounded arch dormers flank the pediment gable. The second floor of the central pavilion exhibits a Palladian window with Doric pilasters, raised keystone, and Gothic sash.

A one story, wooden portico embellishes the first floor of the pavilion. Paired Tuscan columns support the simple cornice and flat roof. The portico shadows the main entrance. The door is flanked by sidelights and capped by a brick segmented arch lintel with marble impost blocks. The sidelights show their own individual brick jack arch lintels.

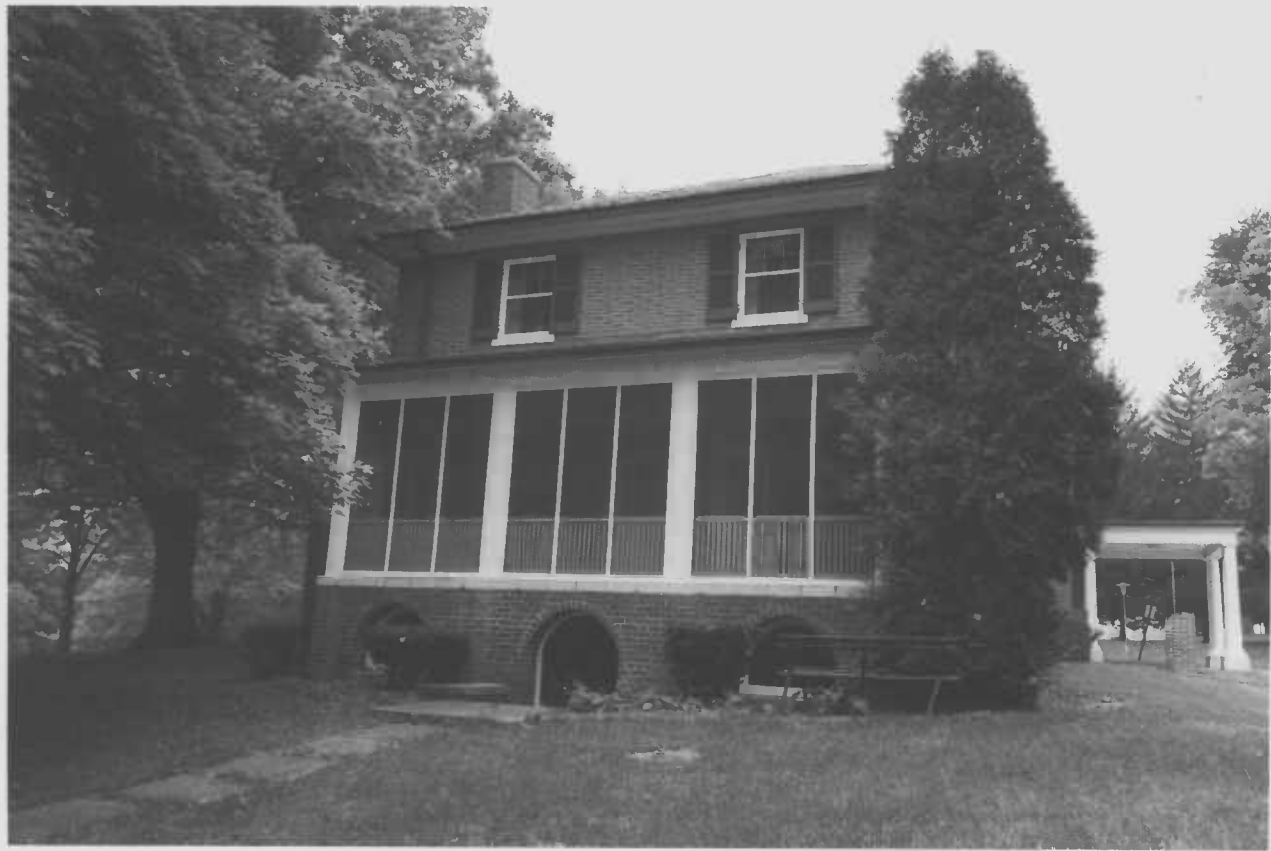
East

The east wall of the building displays a one story screen porch with a shingled, shed roof. The porch rests on a brick base which exhibits three elliptical arches. The middle arch provides access to the basement.
